Groundwater Management Plan for Lowering of
Hospital Road

Randwick Campus Redevelopment
Hospital Road and Delivery Drive, Randwick

Prepared for
Lendlease Building Pty Ltd

Project 72505.13
March 2020

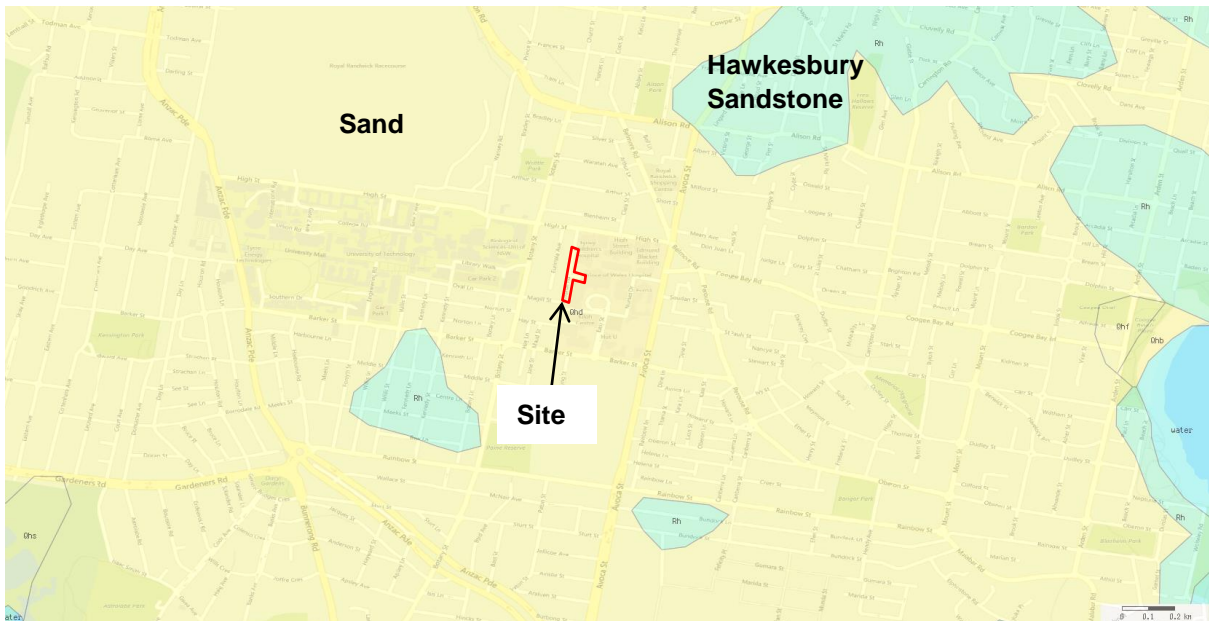
Figure 2: Regional Geology (Source: Sydney 1:100 000 Series Geological Sheet)

Reference to the Sydney 1:100 000 Series Geological Sheet indicates that the site is underlain by fine to medium grained sand (shown in yellow in Figure 2). Hawkesbury Sandstone comprising medium to coarse grained quartz sandstone with minor shale and laminite bands (shown in green in Figure 2) is

present in areas to the north-east, south-east and south-west of the site. The previous investigations confirmed the presence of sand over Hawkesbury Sandstone with minor laminite bands.

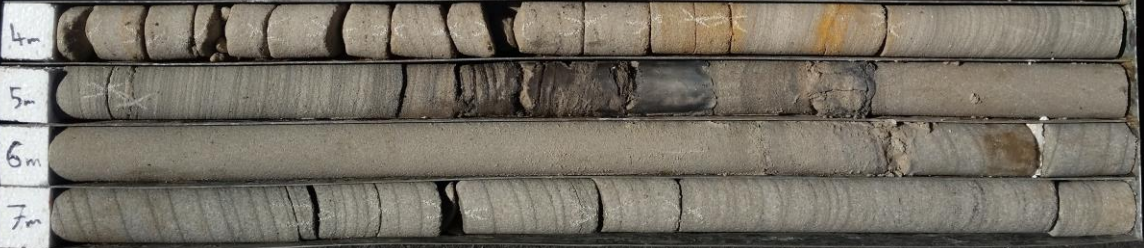
3.9m - 8.0m

72505-11 RANDWICK BH1 Start at 3.9m

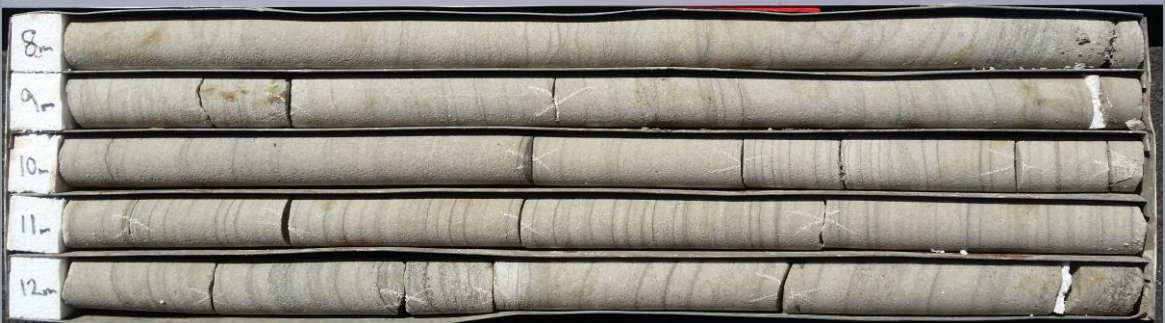
8.0m - 13.0m

Project No: 72505-11
BH ID: BH1
Depth: 8m - 13m
Core Box No.: 2/3

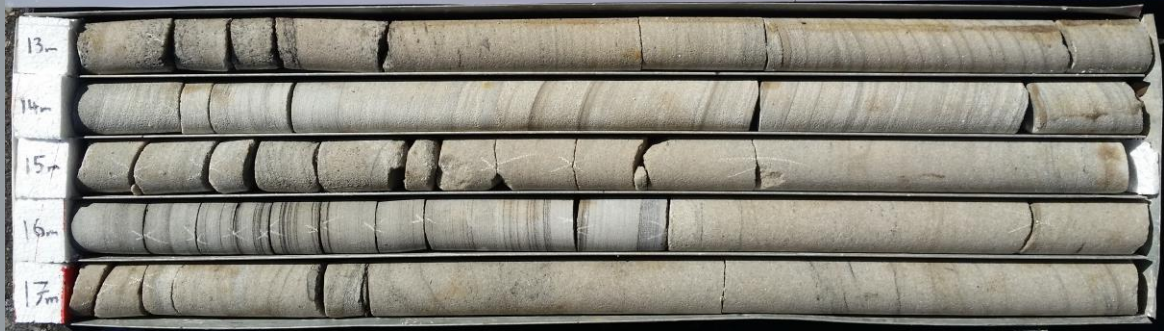
13.0m - 18.0m

Project No: 72 505-11
BH ID: BH1
Depth: 13m - 18m
Core Box No.: 3/3

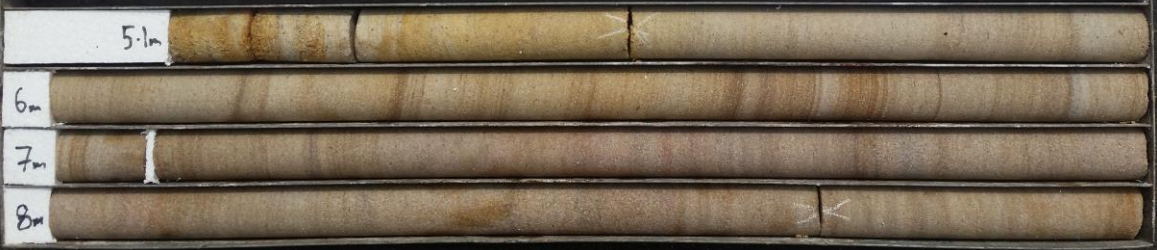
5.1m - 9.0m

72505-11 RANDWICK BH2 start at 5.1m

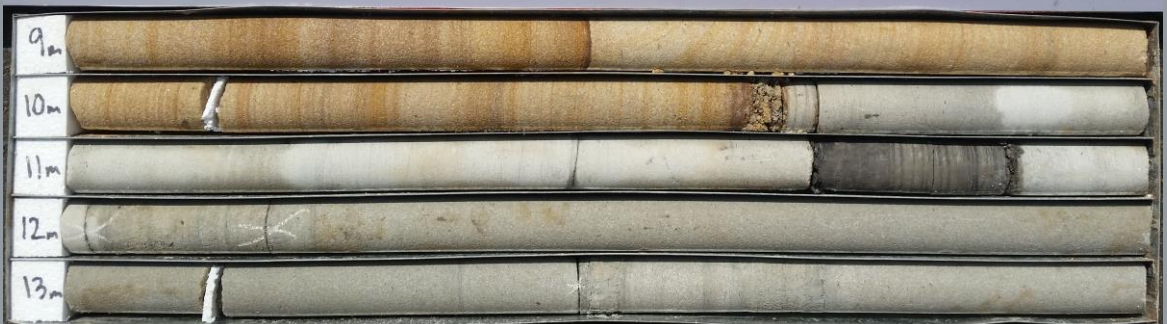
9.0m - 14.0m

Project No: 72505-11
BH ID: BH2
Depth: 9m - 14m
Core Box No.: 2/3

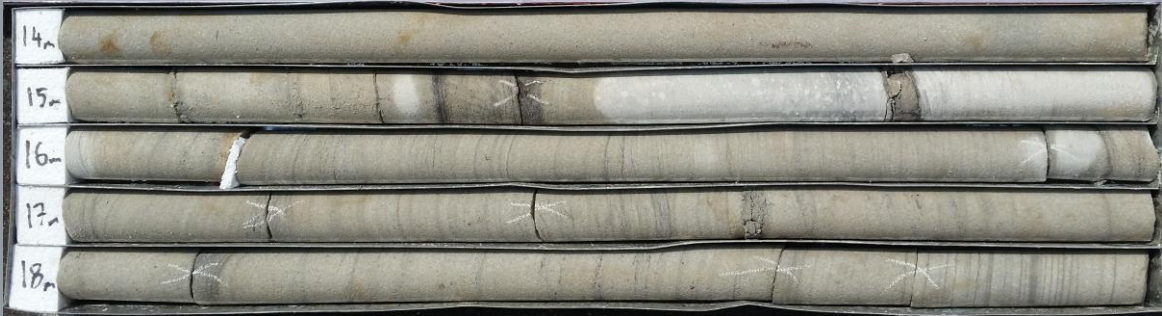
14.0m - 19.0m

Project No: 72505-11
BH ID: BH 2
Depth: 14m - 19m
Core Box No.: 3/3

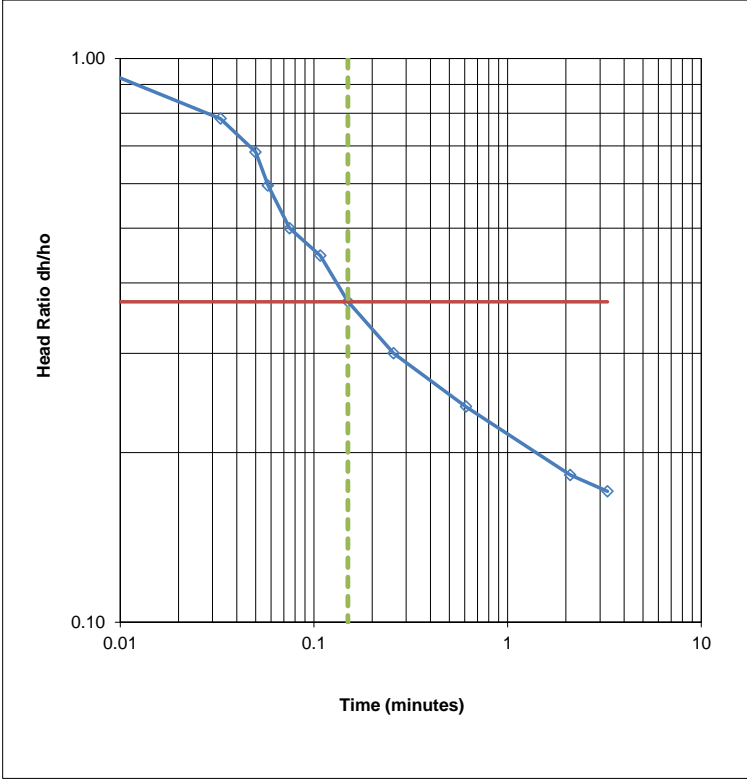
Details of Well Installation					
Well casing diameter (2r)	50	mm	Depth to water before test	4.5	m
Well screen diameter (2R)	110	mm	Depth to water at start of test	2.8	m
Length of well screen (Le)	5.1	m

Test Results			
Time (min)	Depth (m)	Change in Head δH (m)	$\delta H/H_0$
0.01	2.88	1.62	0.953
0.03	3.17	1.33	0.782
0.05	3.34	1.16	0.682
0.06	3.49	1.01	0.595
0.08	3.65	0.85	0.500
0.11	3.74	0.76	0.447
0.15	3.87	0.63	0.371
0.26	3.99	0.51	0.300
0.61	4.09	0.41	0.241
2.11	4.19	0.31	0.182
3.28	4.21	0.29	0.171

To = 0.15 Min
9 Sec

Theory: Falling Head Permeability calculated using equation by Hvorslev
 $k = [r^2 \ln(Le/R)] / 2Le T_0$ where r = radius of casing
 R = radius of well screen
 Le = length of well screen
 T_0 = time taken to rise or fall to 37% of initial change

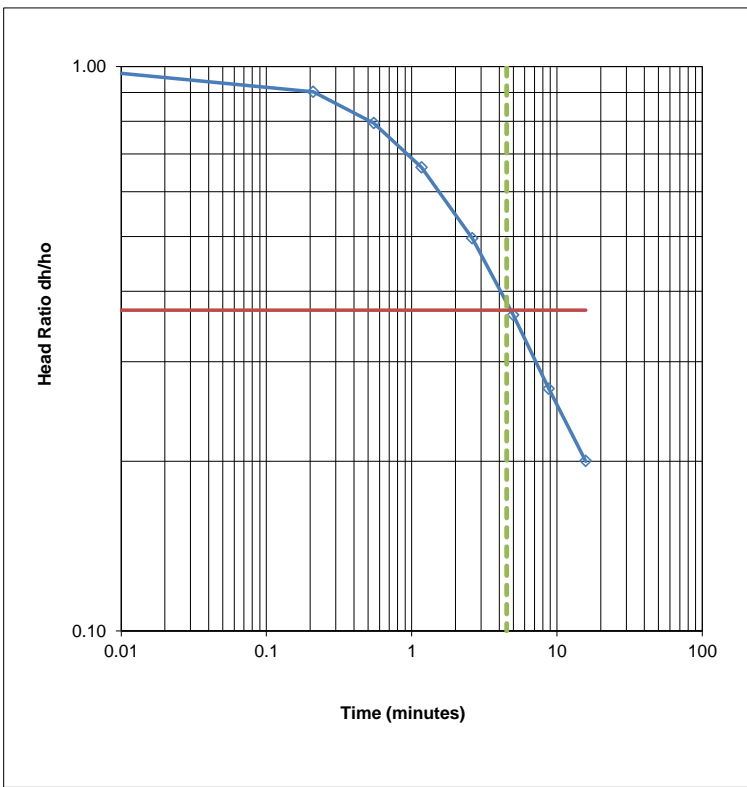
Details of Well Installation					
Well casing diameter (2r)	50	mm	Depth to water before test	5.1	m
Well screen diameter (2R)	100	mm	Depth to water at start of test	0	m
Length of well screen (Le)	5	m

Test Results			
Time (min)	Depth (m)	Change in Head δH (m)	$\delta H/H_0$
0.01	0.11	4.99	0.978
0.21	0.50	4.60	0.902
0.55	1.05	4.05	0.794
1.17	1.72	3.38	0.663
2.62	2.57	2.53	0.496
5.01	3.25	1.85	0.363
8.78	3.73	1.37	0.269
15.77	4.08	1.02	0.200

To = 4.5 Min
270 Sec

Theory: Falling Head Permeability calculated using equation by Hvorslev
 $k = [r^2 \ln(Le/R)] / 2Le To$ where r = radius of casing
 R = radius of well screen
 Le = length of well screen
 To = time taken to rise or fall to 37% of initial change

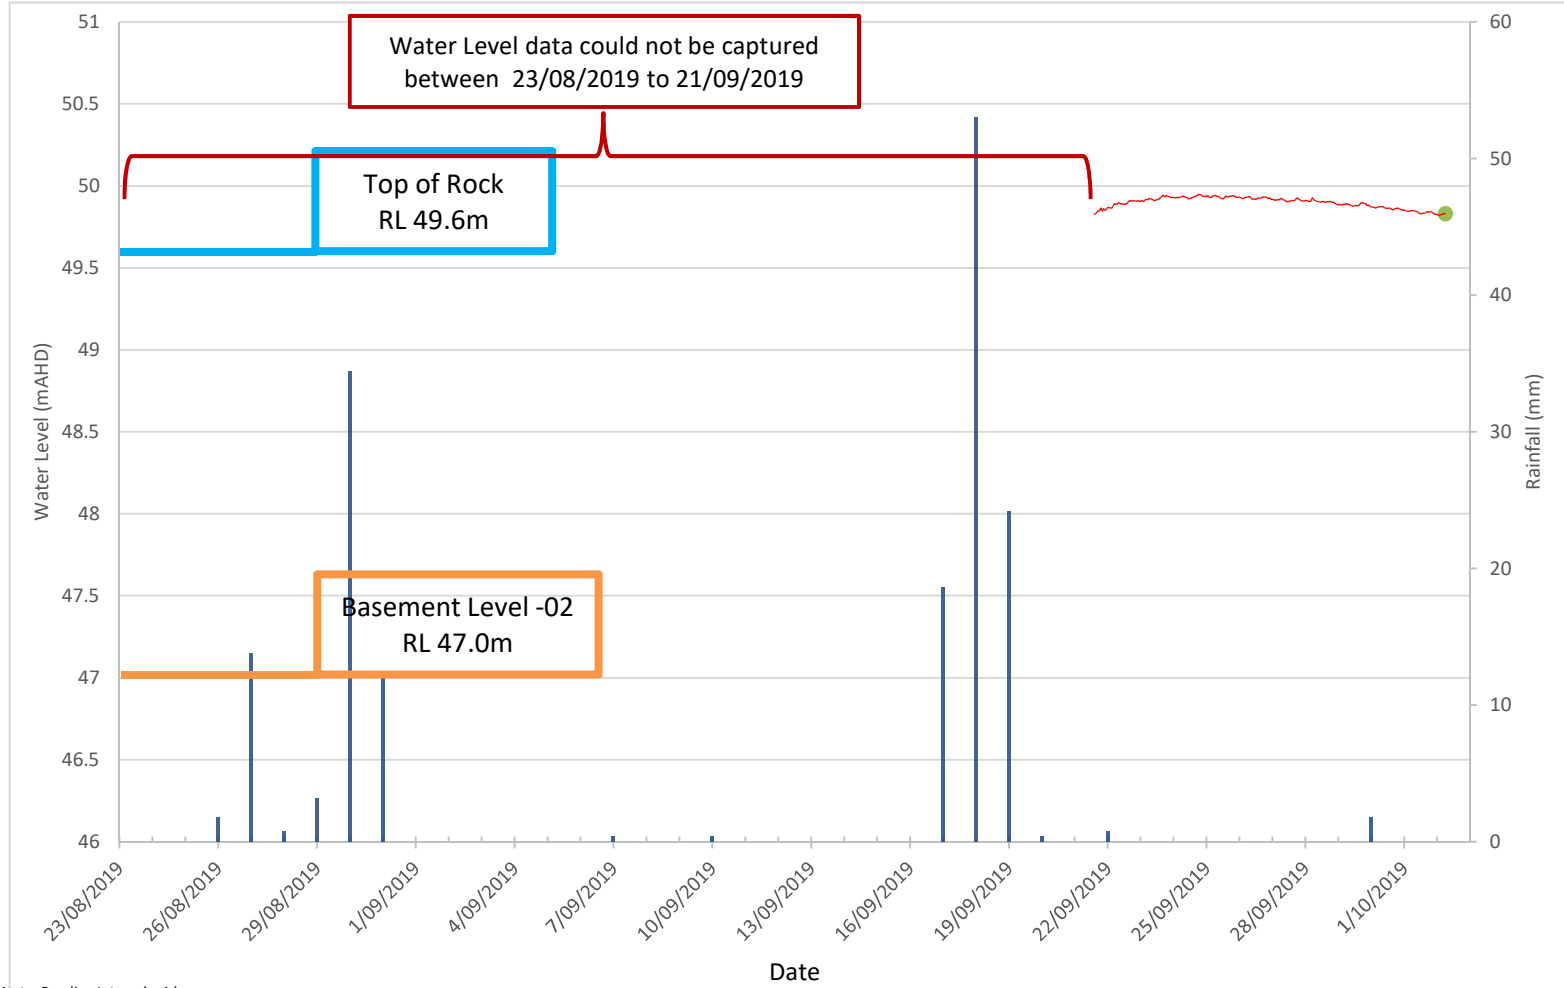
BH12

Note: Reading Interval = 1 hour
